WATER OPERATION AND MAINTENANCE BULLETIN

No. 197

September 2001

- A Low-Cost Automated Farm Turnout for Better Water Management
- Bedliner for Coal Tar Spot Repairs
- Status Update of the Flexible Pipe Study Team
- High-Pressure Siphon Repair – Rogue Basin Project

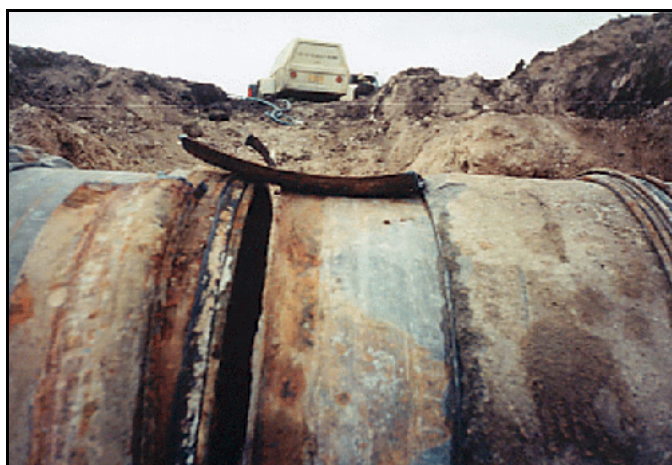
Cover photograph: *Damaged joint showing rusted area.*

Upon starting the irrigation season in April 2000, a leak was discovered in the high-pressure Billings Siphon which transfers water from the East Canal to the West Canal (approximately 1.25 miles across the valley). This line is a 30-inch, pre-stressed mortar-lined, steel concrete-coated pipe. The design capacity of this siphon is 32 cubic feet per second (cfs). The leak was in an area that has some springs and is directly above the Port of Entry at Ashland, Oregon (on the Interstate 5 Freeway), and was approximately 1.5 cfs. Because of its location, and because the Port of Entry has a drain system surrounding the facility, the leak appeared to have been undetected in the prior season.

Once the leak was detected in the Billings Siphon, repairs began immediately to ensure that water would be distributed to 2,300 acres of land and that there would be no safety hazards because of the depth of the line. The line was approximately 15 feet deep and in very saturated clay soil. The excavation to expose the line took almost 1 day because the Talent Irrigation District had to lay the side slopes of the excavation back to ensure that a cave-in would not occur. Approximately 200 cubic yards of material was removed in this process.

After exposing the line, it was found that a rock in the original backfill had fractured the cement mortar outer coating directly adjacent to a joint in the pipe; moisture caused the joint to rust from the outside, causing it to fail.

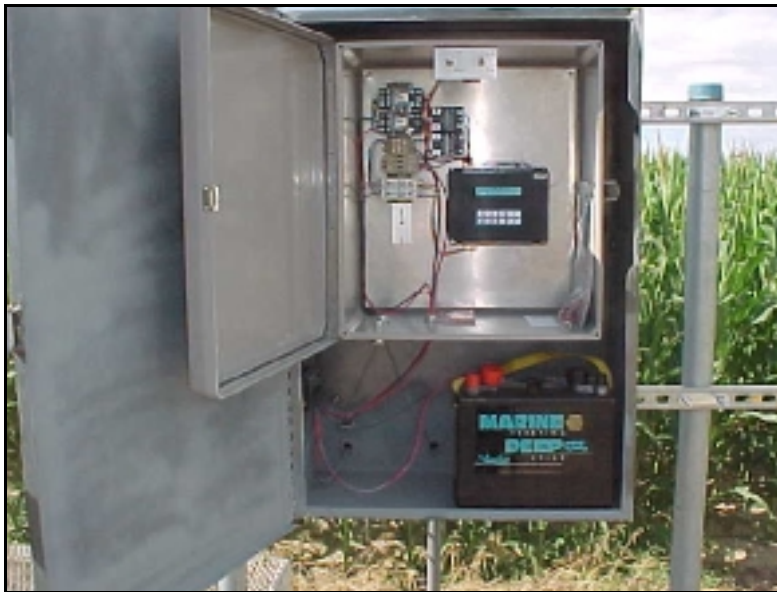
Figure 1.—Control box showing CPU, interface electronics, and battery.

components, including an LCD screen and switches as well as additional fabrication costs. The total price of the less expensive CPUs with the additional fabrication costs came to about \$300. When the lower-cost CPUs were tested, they exhibited some minor compiler problems, and it was feared that these problems would escalate in the field. The most expensive CPUs suited the application, but they were not selected because of their higher cost. A CPU that cost about \$420 was finally chosen for this application (figure 1).

The selected CPU is an industrial process controller that can be programmed in C and assembly languages. It is manufactured with a built-in LCD and keypad, which minimized fabrication and assembly costs. The LCD and keypad give the operator the capability of displaying flow rates, displaying total amounts of diverted water, and changing flow set points. The CPU is programmed to receive feedback from a water-level sensor which is located downstream of the turnout control gate. It also receives feedback from a gate position sensor. Various types of sensors will work with this controller—all that is required is that the sensor outputs a voltage or current signal.

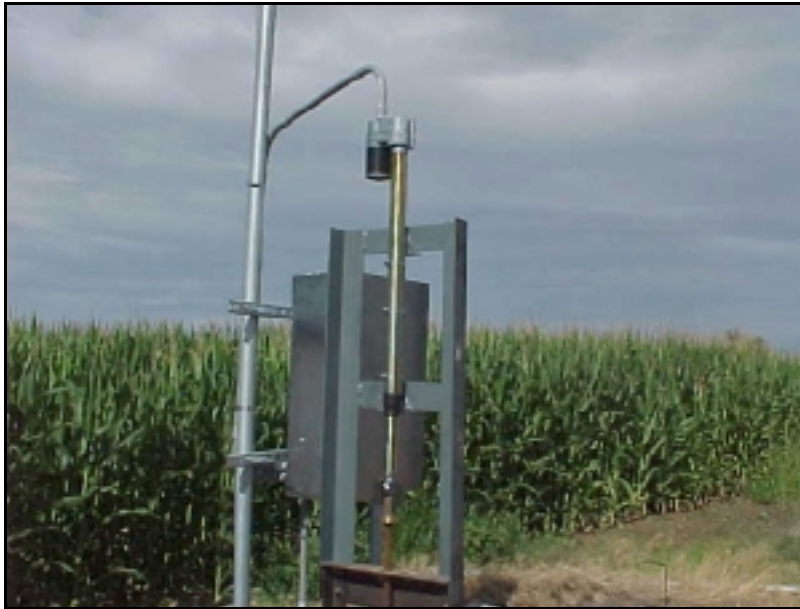
*Figure 3.—The linear actuator that is used to move the turnout gate.
This turnout uses a waterman gate.*

The actuator is a mass-produced product that was originally designed to move satellite dishes (figure 3). It is relatively inexpensive, readily available, and has limit switches and a position sensor mounted internally. This reduces the cost of the AFT because fabrication costs are reduced and additional components are not required. This actuator has a maximum operating

span of 0.6 meter and can exert an operating force of 273 kilograms. It has been well suited for the application because all of the sites have gate movements that are less than 0.6 meter.

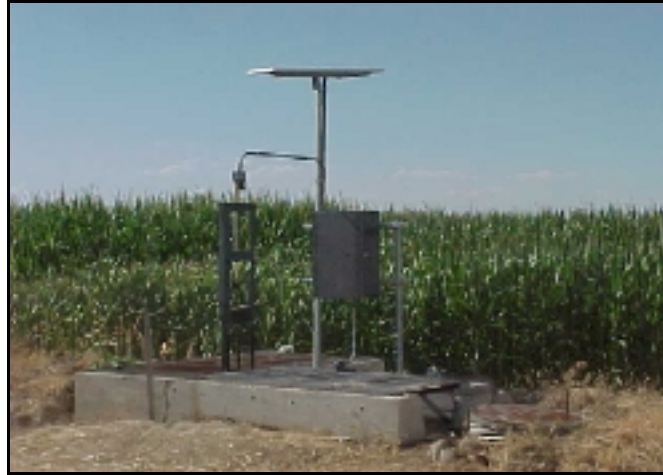
Figure 5.—The complete AFT unit. The gate diverts water to the right over a Cipolletti Weir. The water then runs down the vertical culvert into a piping system.

The AFT has been installed on three farm turnouts near Boise, Idaho (figure 5). Testing of these sites was conducted throughout the latter half of the 2000 irrigation season. An additional AFT was installed in Yuma, Arizona, in the spring of 2001. So far, all system components have functioned properly in the intense summer heat as well as the humidity and dust. The AFTs were left in the field during the nonirrigation season to see how well they endure the winter months. Plans are underway to install this device on other farm turnouts to determine its ability to operate in a variety of canal environments. All of the farmers involved appear to be comfortable with the technology and are capable of maintaining most of the components in the system. It also appears to be beneficial to have the farmers participate with the installation so that they are familiar with the system and how it works.

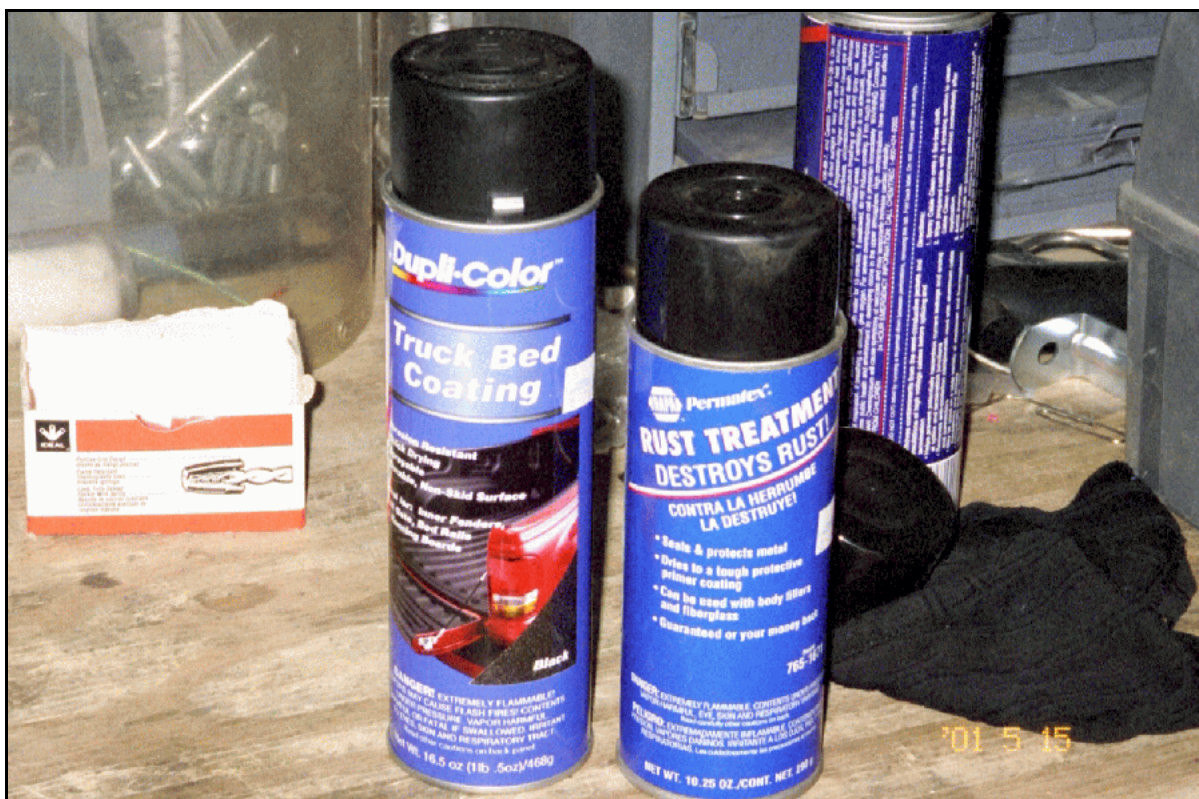
El Vado runner hub after removing loose material.

The initial step of a repair requires maintenance personnel to clean the affected area of any loose coatings and rust and then apply a rust treatment as the primer coat. To finish the repair, personnel use the bedliner coating. A product hardy enough to withstand abuse and weathering in the bed of a truck seems to work for the water released through power penstocks.

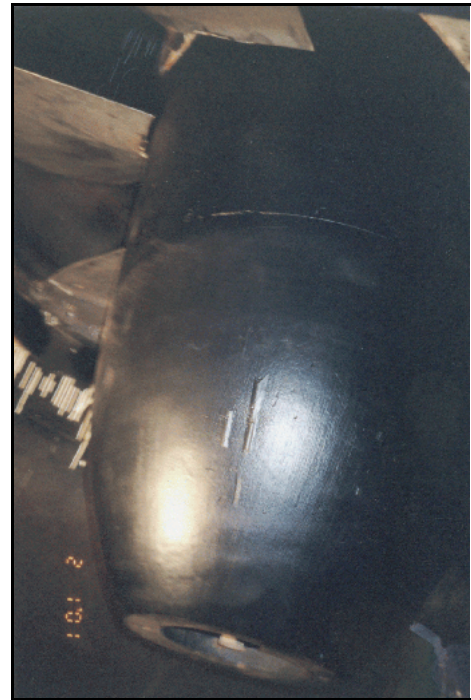
El Vado runner hub after coating with pick-up bedliner.

This is the first time the coating has been used in this particular application, and it will not be known how well the coating held up until the next unit inspection (*note*: a followup article will be printed regarding the durability of the repair method). Mr. Kennedy (505) 662-8216, or Bob Major in the Albuquerque Area Office (505) 248-5368, can supply more details about the repair longevity and procedures.

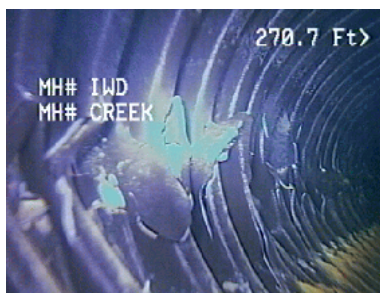
*San Justo Dam;
18-inch-diameter HDPE.*

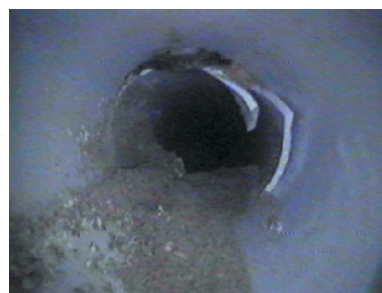
*Washakie Dam;
8-inch-diameter PVC.*

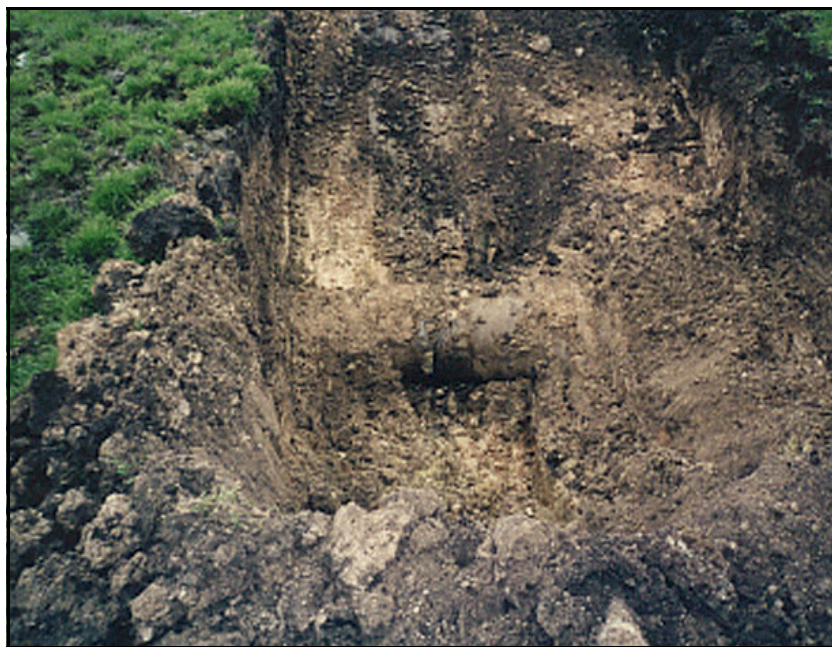
Damaged area exposed before bank sides have been laid back.

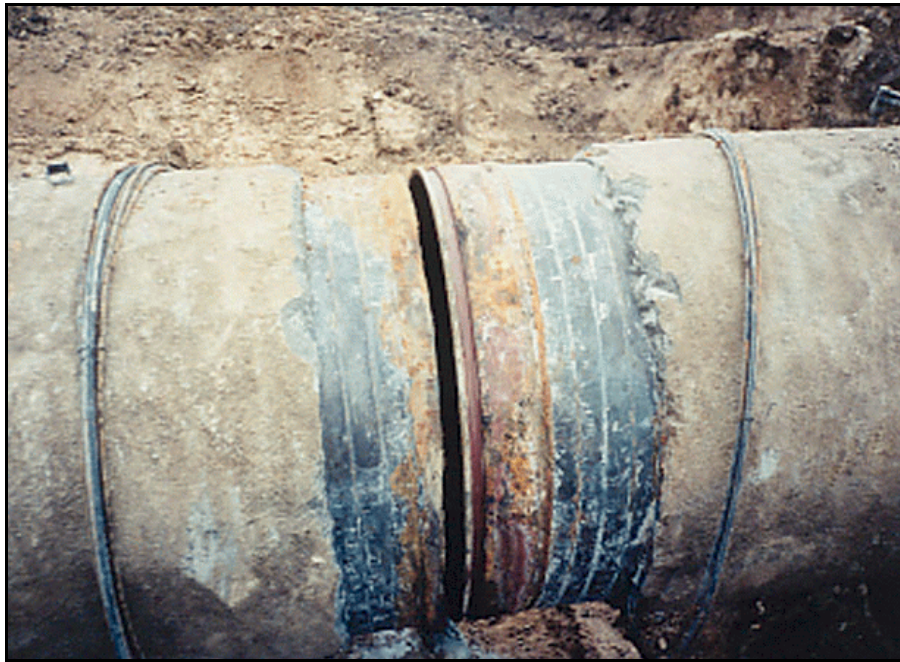
Damaged joint exposed.

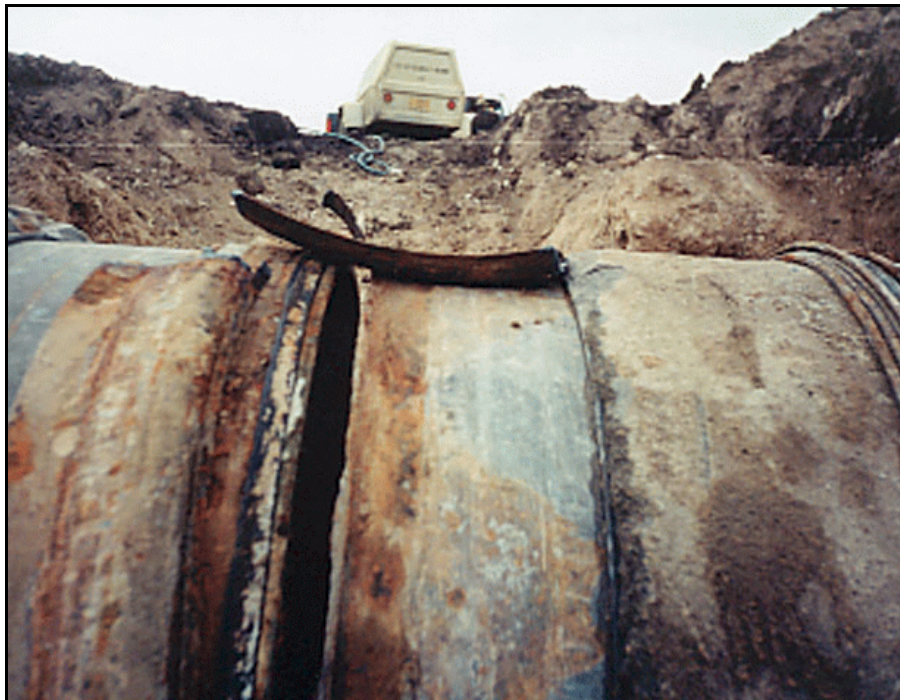
Damaged joint showing rusted area.

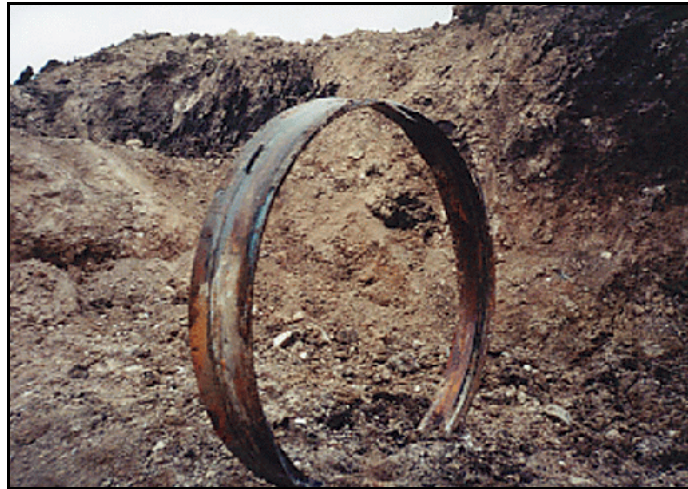
A cut out damaged joint.

To complete this repair, the joint had to be cut out and a section welded into the pipe. To accomplish this, the cement mortar outer covering had to be removed back to a point that allowed room to work. Air impact chisels worked well for this procedure. The next step was to expose solid pipe that could be welded to; this meant cutting out an approximate 1-foot section of the pipe. A local tank manufacturer rolled a 15-inch section of 1/8-inch plate to the outside diameter of the pipe. The ring was then cut into two sections to allow the district to install it on the pipe. The half sections were placed on the pipe and held in place with a come-a-long to reduce warping while being welded. A chain was placed around the pipe, and a port-a-power was used to put pressure directly on the area being welded. Shorter sections were then welded and alternated from side to side to keep warping to a minimum. The welding was done with a portable wire feed.

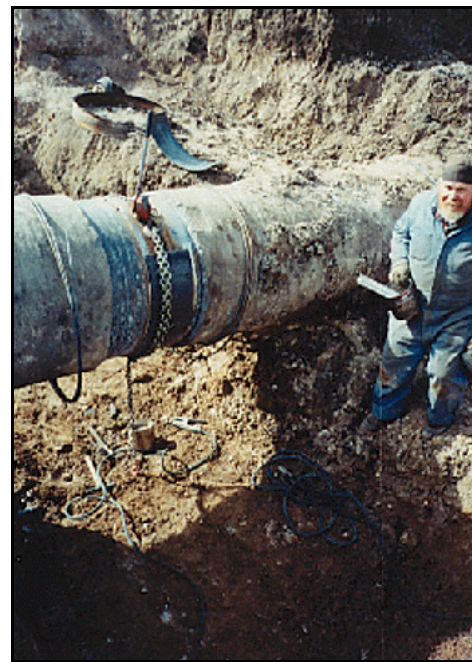
Repair sections clamped in place before welding.

The pipe was pre-stressed with a wire wrapped around it. Once the outside mortar set, the pre-stressed wire was rewound around the pipe and the two ends pulled tight together. The ends were held in place with vice grips while lap welding. The repair was now complete.

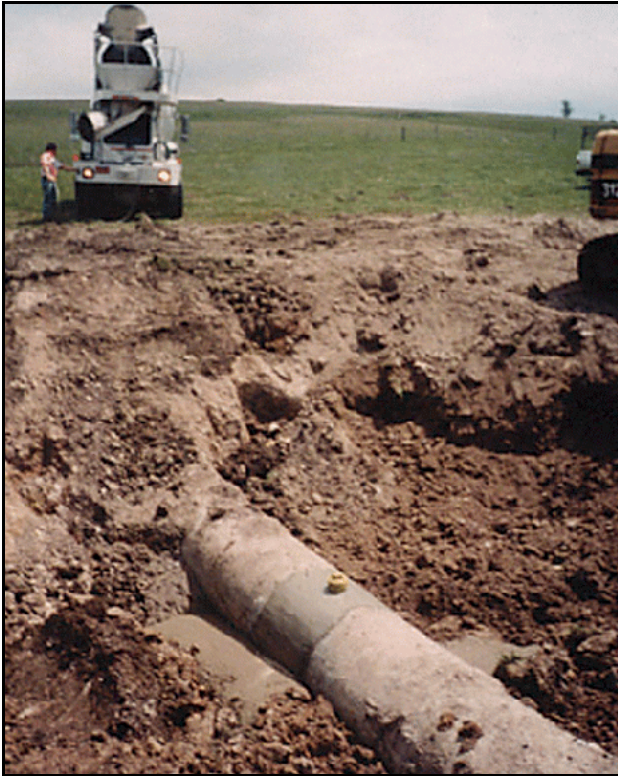
Completed repair before final backfilling. Notice the access plug at the 12 o'clock position to facilitate interior pipe coating. Two other plugs are located at the 8 and 4 o'clock positions.

Once both halves were welded into place, the next step was to gain access to the inside of the pipe in order to replace the mortar lining. Holes were cut, and 4-inch, high-pressure couplings at 12, 4, and 8 o'clock were welded into place around the pipe. This allowed the crew to reach inside and coat the inside bonding agent which would allow the mortar to stick. Then, the fast-set mortar was mixed with the bonding agent, which makes up about half the moisture content in the mixture, with water being used for the remainder. This made the mortar sticky and easy to keep in place on the crown of the pipe. The mixture was applied with a sponge trowel. With the inside now coated with mortar, 4-inch plugs were installed in the couplings. Both the plugs and couplings were black iron and coated in zinc chromate primer. The same mortar mix that was used to coat the inside of the pipe was also used to coat the outside of the pipe.

To accomplish the backfill, the excavation was closed and compacted to within about 2 feet of the repair. The area adjacent to the pipe was left open. The area under the pipe was left undisturbed. A 1.5 sack slurry mix was poured into the open area around the pipe and up the sides to the top one-third of the pipe. This was left open for 24 hours. The line was then charged.
